Project: Pinchot Lake Bank Stabilization Project
Client: Izaak Walton League of America
Location: York County, Pennsylvania

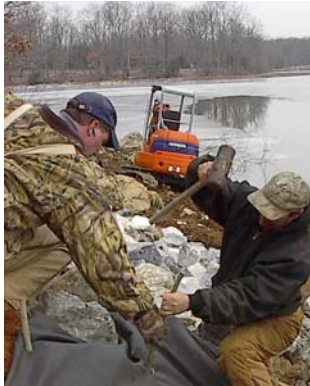
One of the major sources of nutrients and sediments to the lake is stream bank and lake shoreline erosion. The worst case of lake shoreline erosion was occurring within Loop B of the campground area. At Loop B, a 500-foot section of the lake shoreline was severely eroding due to wave action, surface water runoff and heavy pedestrian foot traffic. Heavy pedestrian foot traffic was primarily due to park visitors gaining access to the lake from their campsites.

In February 2002, Aqua-Link stabilized and restored a 500-foot section of severely eroded lake shoreline. Funding for this project was provided by the Pennsylvania Department of Environmental Protection (PA DEP) through its Growing Greener Grant Program. Severely eroded lake banks were stabilized and restored using soil bio-engineered and natural bank design principles.

For this project, native rock (iron stone), live stakes and live fascines were utilized. Live stakes (cuttings) and live fascines (“sausage like” bundles of branches) were created using branches from willow trees. During construction, several mature trees had to be cut down to maneuver construction equipment. These trees were later re-anchored horizontally into the bank and now serve as habitat for the lake’s fishery.
